Manhole Inspection Summary

Manhole # S31I11004MH

Insp Date: **3/20/07 1:06 PM**

Location Address: **305 TUSCANY RD**

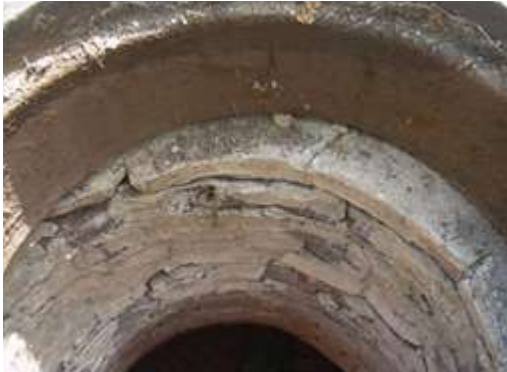
Defect

deteriorated chimney

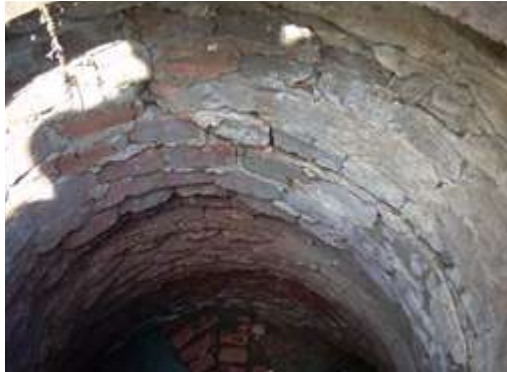
Defect

infiltration in mh

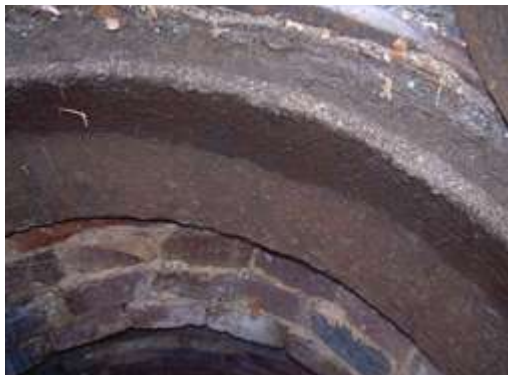
Defect

frame leaks

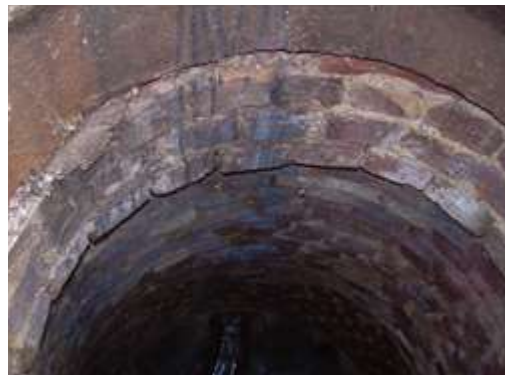
Defect

infiltration in mh

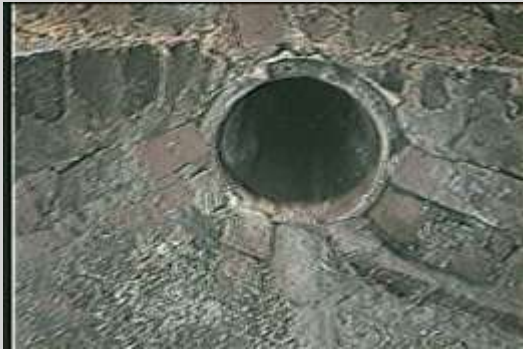
8 in. Circular Gravity Sewer Pipe Out @ 12 O'Clock

Infiltration: **None** Pipe Seal Cond: **Sound**

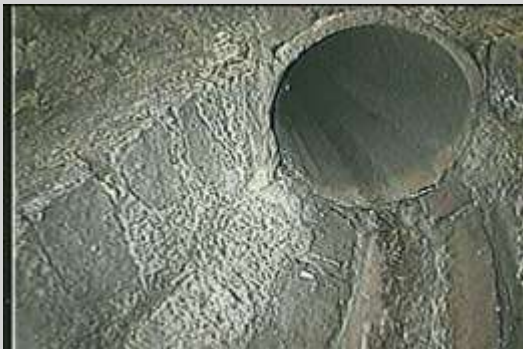
8 in. Circular Gravity Sewer Pipe In @ 3 O'Clock

Infiltration: **None** Pipe Seal Cond: **Sound**

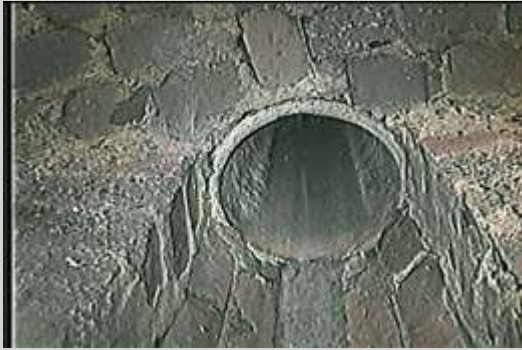
Pipe In @ 6 O'Clock

Infiltration: **None** Pipe Seal Cond: **Sound**

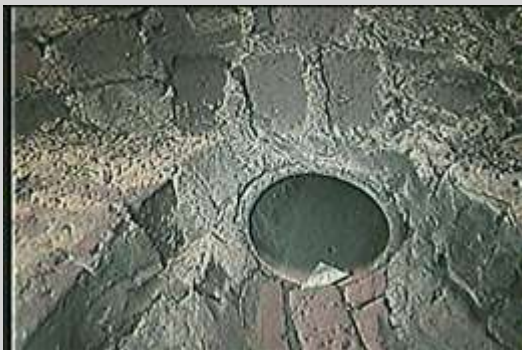
Pipe In @ 9 O'Clock

Infiltration: **None** Pipe Seal Cond: **Sound**
